Noise Monitoring Assessment

Teven Quarry, Teven, NSW
Quarter 1 Ending March 2020.

Prepared for: Holcim (Australia) Pty Ltd

Prepared by: Muller Acoustic Consulting Pty Ltd

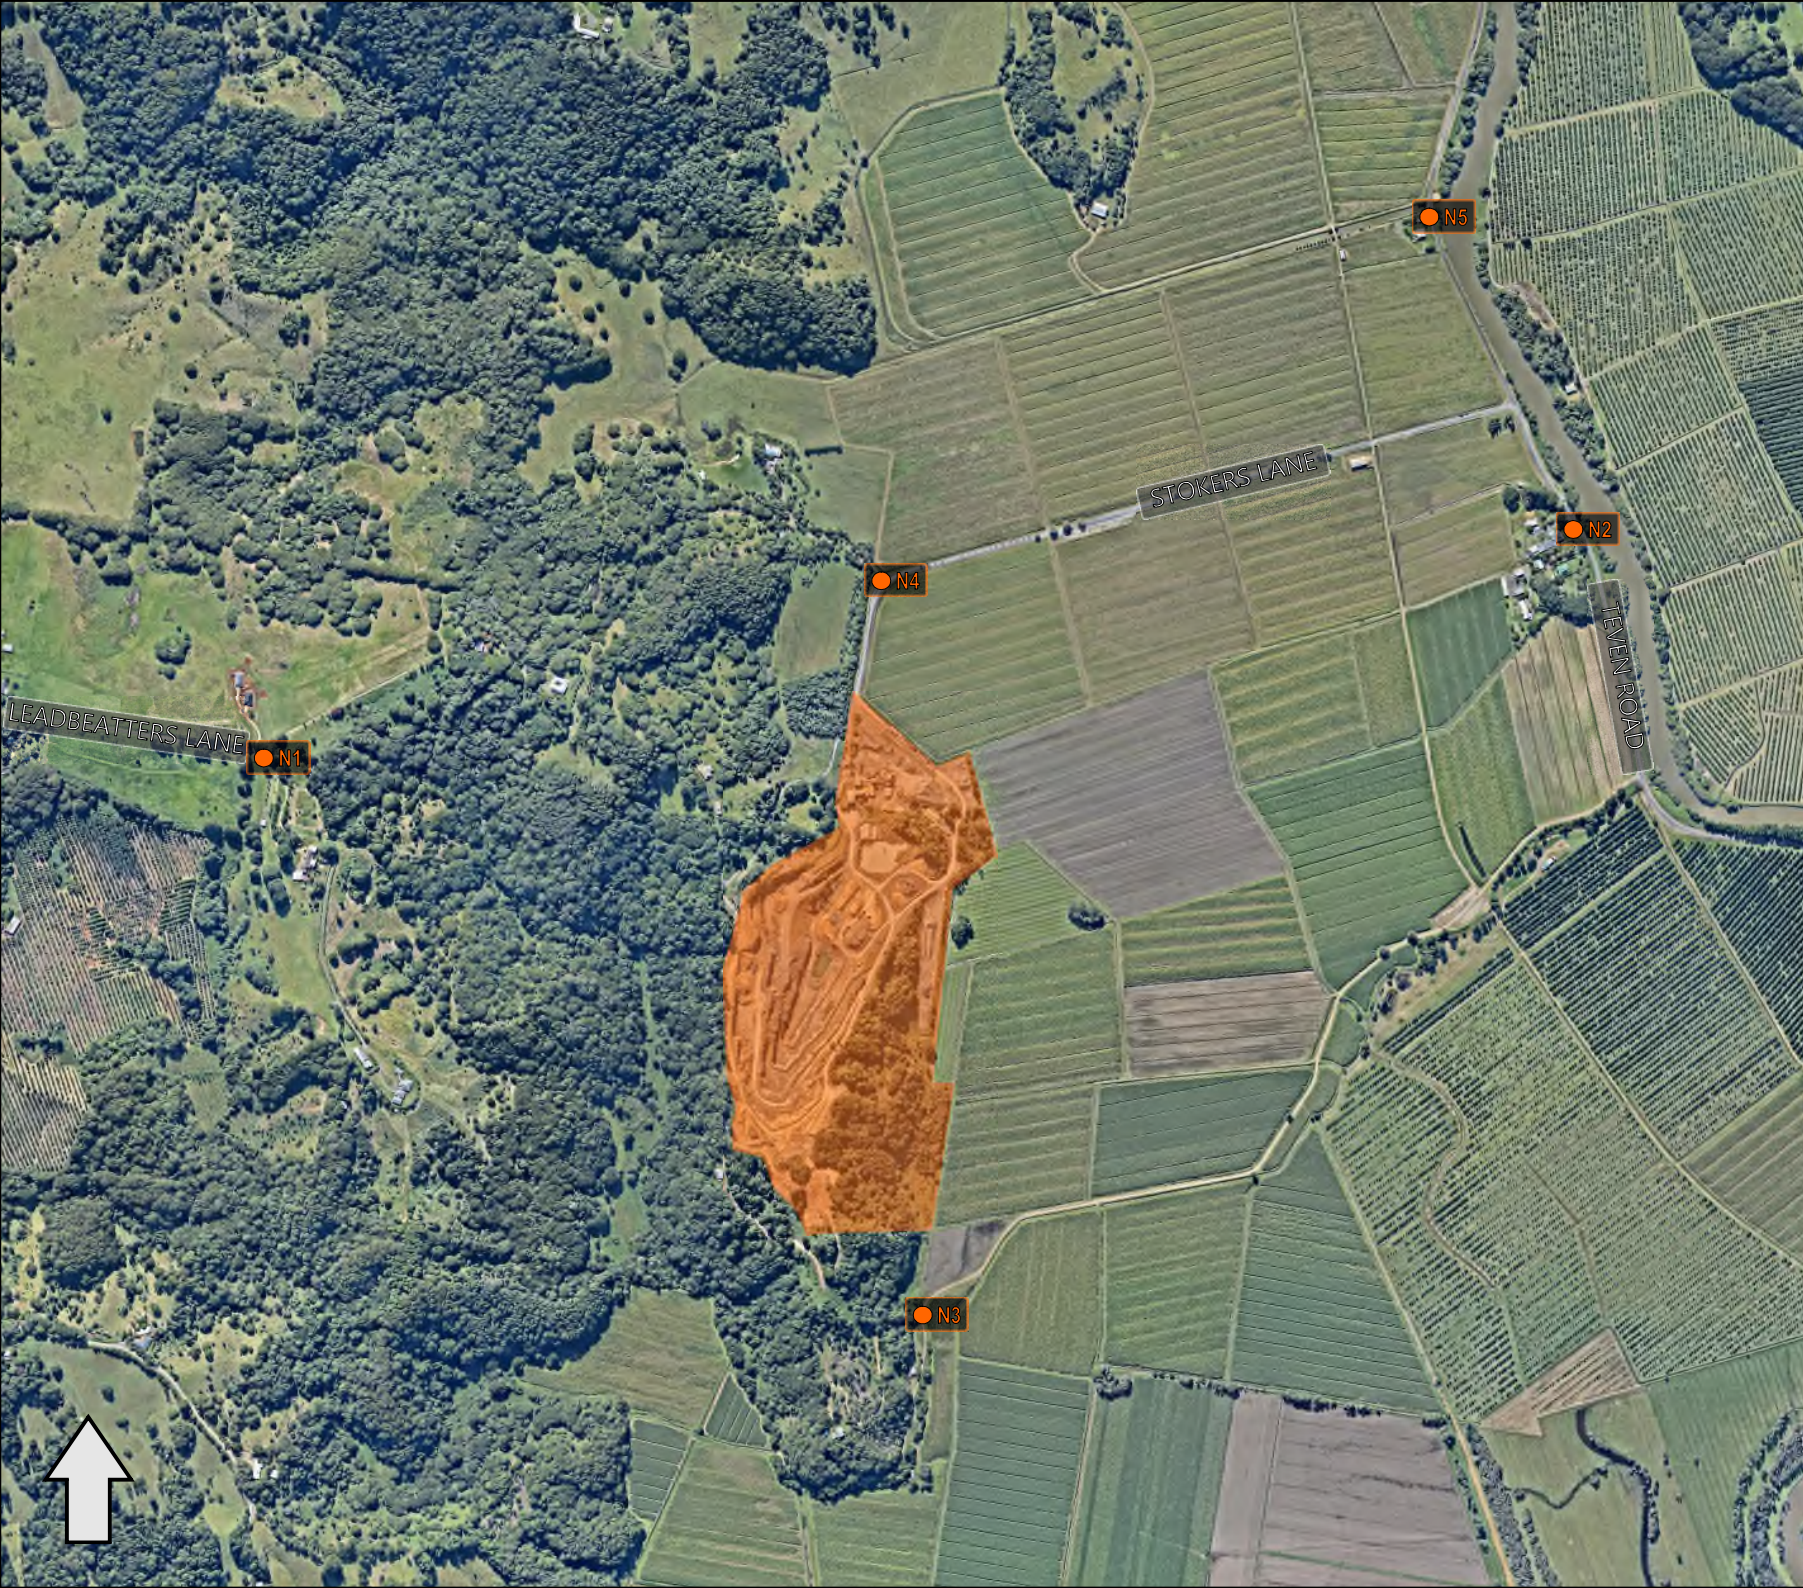
FIGURE 1
LOCALITY PLAN
REF: MAC180611-06

The quarry is located in Teven, NSW approximately 7km west of Ballina, NSW. Receivers in the locality surrounding the quarry are primarily rural residential. The surroundings of the quarry are primarily rural. The monitoring locations with respect to the quarry are presented in the locality plan shown in **Figure 1**.

Location	Nearest Receiver	Easting, m	Northing, m
N1	R7	547017	6810098
N2	R3/R4	548877	6810290
N3	R2	548642	6810801
N4	R10	547729	6810226
N5	R15	547793	6808998

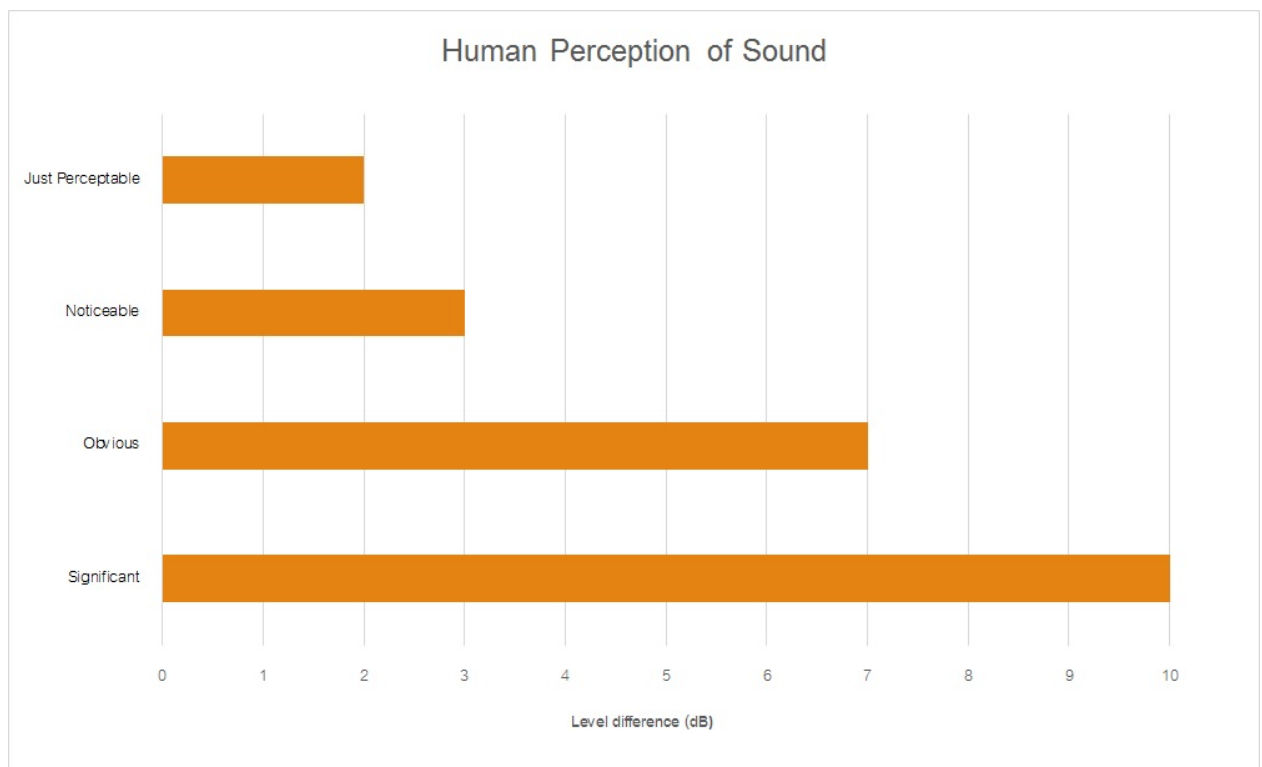
Figure A1 – Human Perception of Sound

Table A2 provides a list of common noise sources and their typical sound level.
