# Noise Monitoring Assessment

Teven Quarry, Teven, NSW Quarter 2 Ending June 2020.

**Noise Monitoring Assessment**

Quarter 2 Ending June 2020

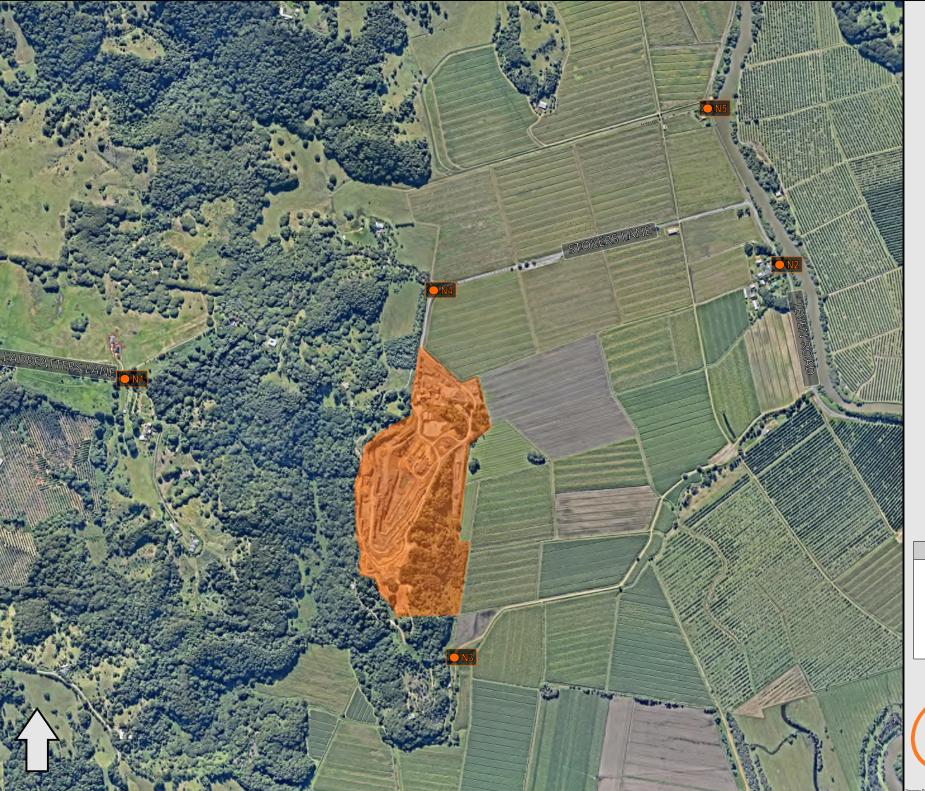
FIGURE 1
LOCALITY PLAN
REF: MAC180611-06

The quarry is located in Teven, NSW approximately 7km west of Ballina, NSW. Receivers in the locality surrounding the quarry are primarily rural residential. The surroundings of the quarry are primarily rural. The monitoring locations with respect to the quarry are presented in the locality plan shown in **Figure 1**.
