ANNUAL REVIEW

1 January 2022 – 31 December 2022 Jandra Quarry

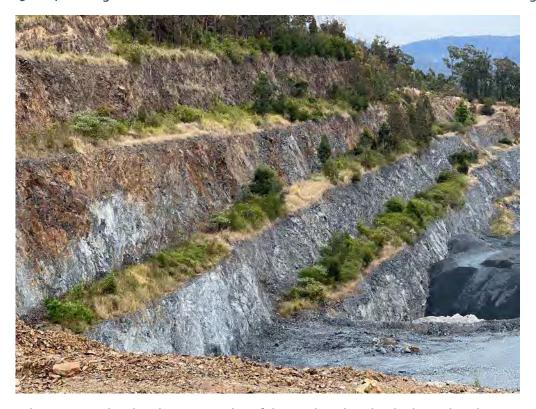
Plate 10: OB2 showing the revegetation of the southern benches in the Active Pit Area

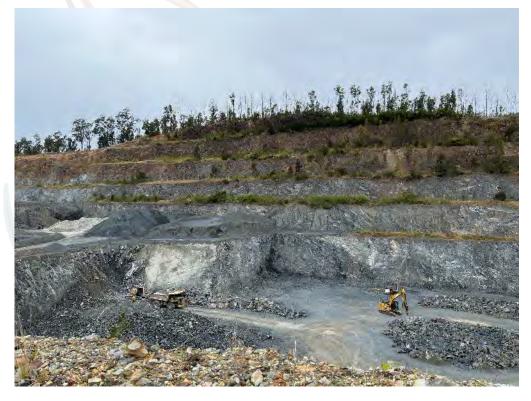
Plate 11: OB3 showing the revegetation of the southern benches in the Active Pit area

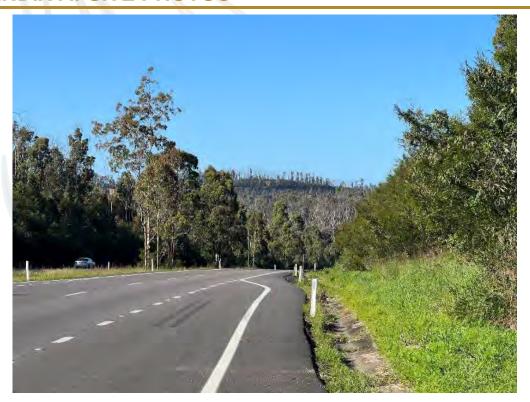
Plate 1: Photo Monitoring Point at the corner of Blackbutts Road and the Pacific Highway

No discernible changes were observed from the photo monitoring points (**Plate 1** and **Plate 2**). The Eucalyptus trees that suffered dieback from the fires are still clearly visible along the ridgeline.

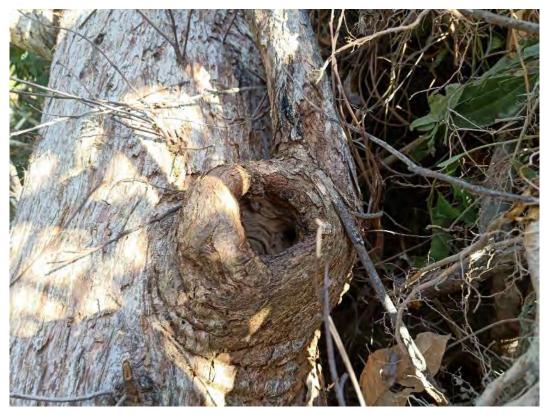
Plate 2 Confirmed Hollow within Eucalyptus carnea (Tree ID 7).

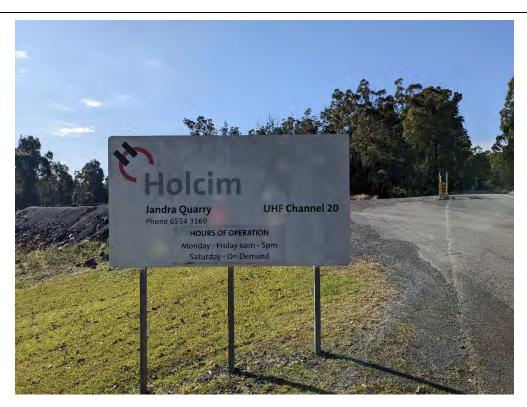
Sign at front entrance displaying site hours of operation and contact details

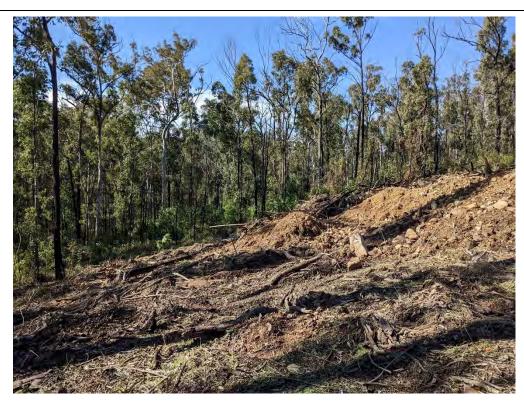
Recently cleared area to the east of the main pit

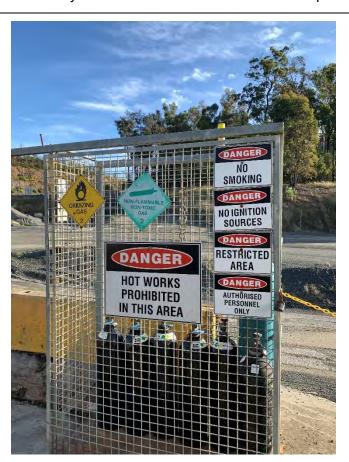
Secured dangerous goods storage on site

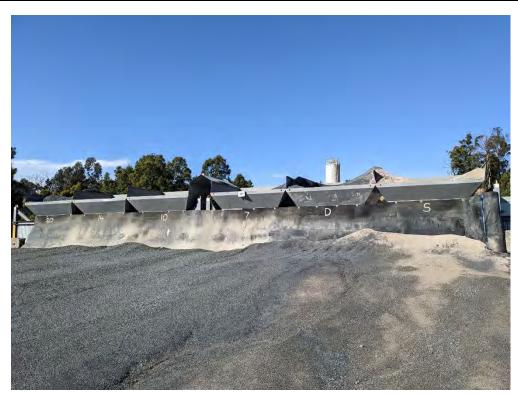
Aggregate storage within the Downer plant area, no evidence of waste asphalt being brought to the site was observed
